## Remote Sensing Based Management of Degraded Soil Due to Brick Industry for Sustainable Development – A Case Study

Surendra Kumar Yadav

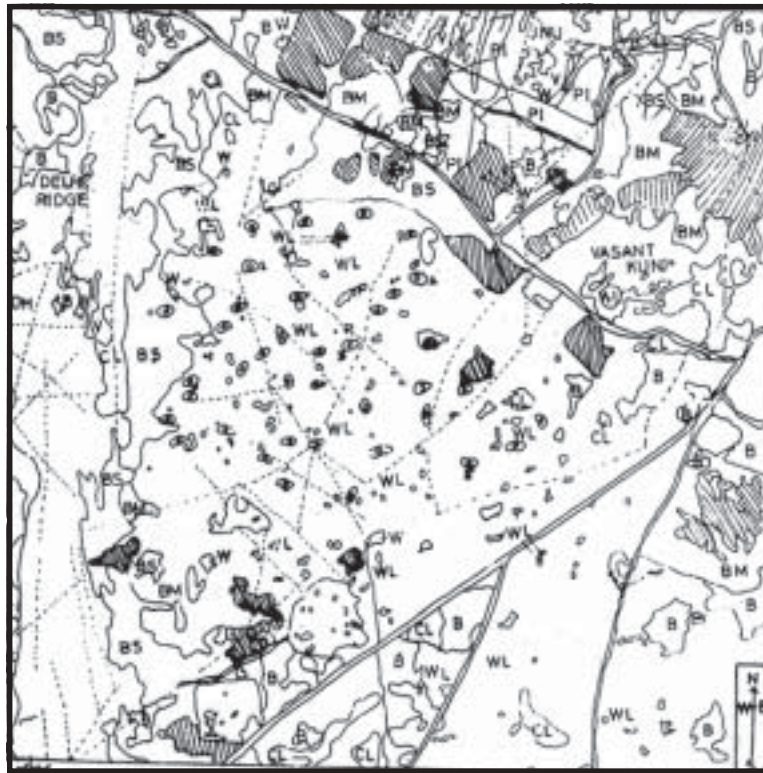
Fig.1 Environs of South Delhi Region  
(Inferred by Spot data with limited field checks)

SPOT F.C.C data, was visually interpreted based on the image interpretation elements, like tone, texture, pattern, association, etc., to study the biogeological aspects of the area, which was correlated with digital enhanced SPOT C.C.T. data. The interpreted information finally transferred to the base maps prepared from Survey of India topographical sheet No.53H/2 on 1:25,000 scale. Delhi guide map was used for field traverses for collection of ground water depth data and soil samples. Total NPK content and pH were estimated as described by Okalebo et al. (1993) for soil samples collected from 20 sites adjacent to 5 brick kilns (numbered 1 to 5 in Fig. 1) in brick kiln complex.

Remote sensing techniques using satellite imagery coupled with soil analysis and field studies were followed for assessment and management of soil degradation due to brick kiln industry through physiographical approach and direct approach. Interpretation of SPOT F.C.C. imagery of South Delhi region shows 42 white patches as brick kilns (main factor for soil degradation) in the south of JNU, new campus and east of Delhi Ridge (Fig.1). Each brick kiln appears as semicircular with very high albedo. The albedo (white patches) are areas of disused and used brick kilns which are in operation since last 50 years approximately as is evidenced by survey of India toposheet also. The mean dimension for each brick kiln is 87 m x 28 m x 9 m. Thus, brick kilns occupied an area of approximately 4.29 square Km. where soil is completely burnt, and about 3.2 square Km. area around these kilns is also adversely affected. Hence, brick kiln complex covers about an area of 7.5 square Km. In degraded soil, moisture content as well as infiltration capacity has changed as it is inferred in hydromorphogeological map. Soil is completely degraded in this area. Few selected herbaceous and shrubby species like *Boerhavia*, *Calotropis*, *Croton sparsiflorum*, *Cynodon dactylon*, *Datura*, *Eragrostiella*, *Euphorbia hirta*, *Ichnocarpus*, *Pycneus*,
