Sediment Sources, Redistribution, and Management in Ekpoma, Nigeria

Famous Ibhasote Aziegbe

*Department of Geography, Ambrose Alli University, P.M.B.14, Ekpoma, Edo State, Nigeria
E-mail: fuegbe@yahoo.com*

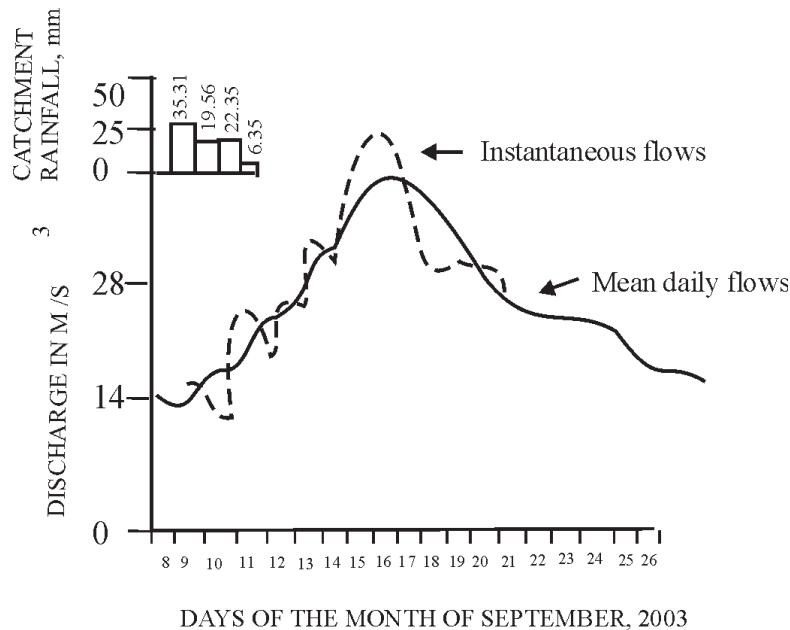
Fig. 1. An example of a slow Rising Flood a Ambrose Alli University Station

Leopold (1974) specified two factors that govern such flow regimes as: (1) the percentage area made impervious and (2) the rate at which water is transmitted across the land and stream channels. Where urbanization is intense, especially on flood plains, the hydrographs often show bursts on the rising limbs, and runoff is instantaneous. Figure 1 exemplifies the flood
